Maryland Historical Trust

Maryland Inventory of Historic Properties number: MD-27-22

Name: 15024/MD 1820 over Buckhorn Branch

SHA Bridge No. 15024 Bridge name MD 182 over Buckhorn Branch

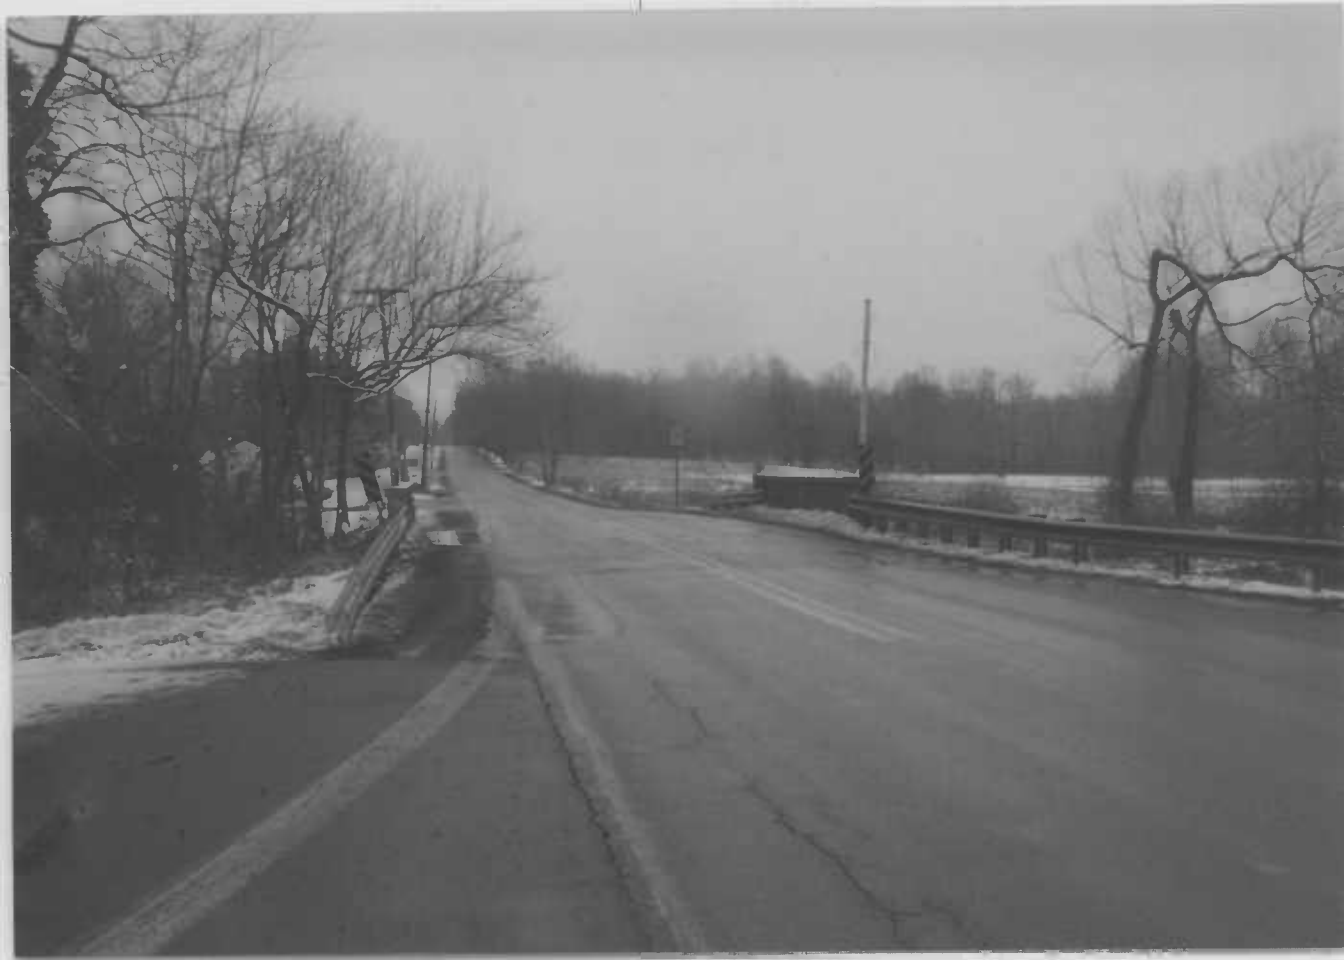
Number 1 of 35 4

Description APPROACH NORTH

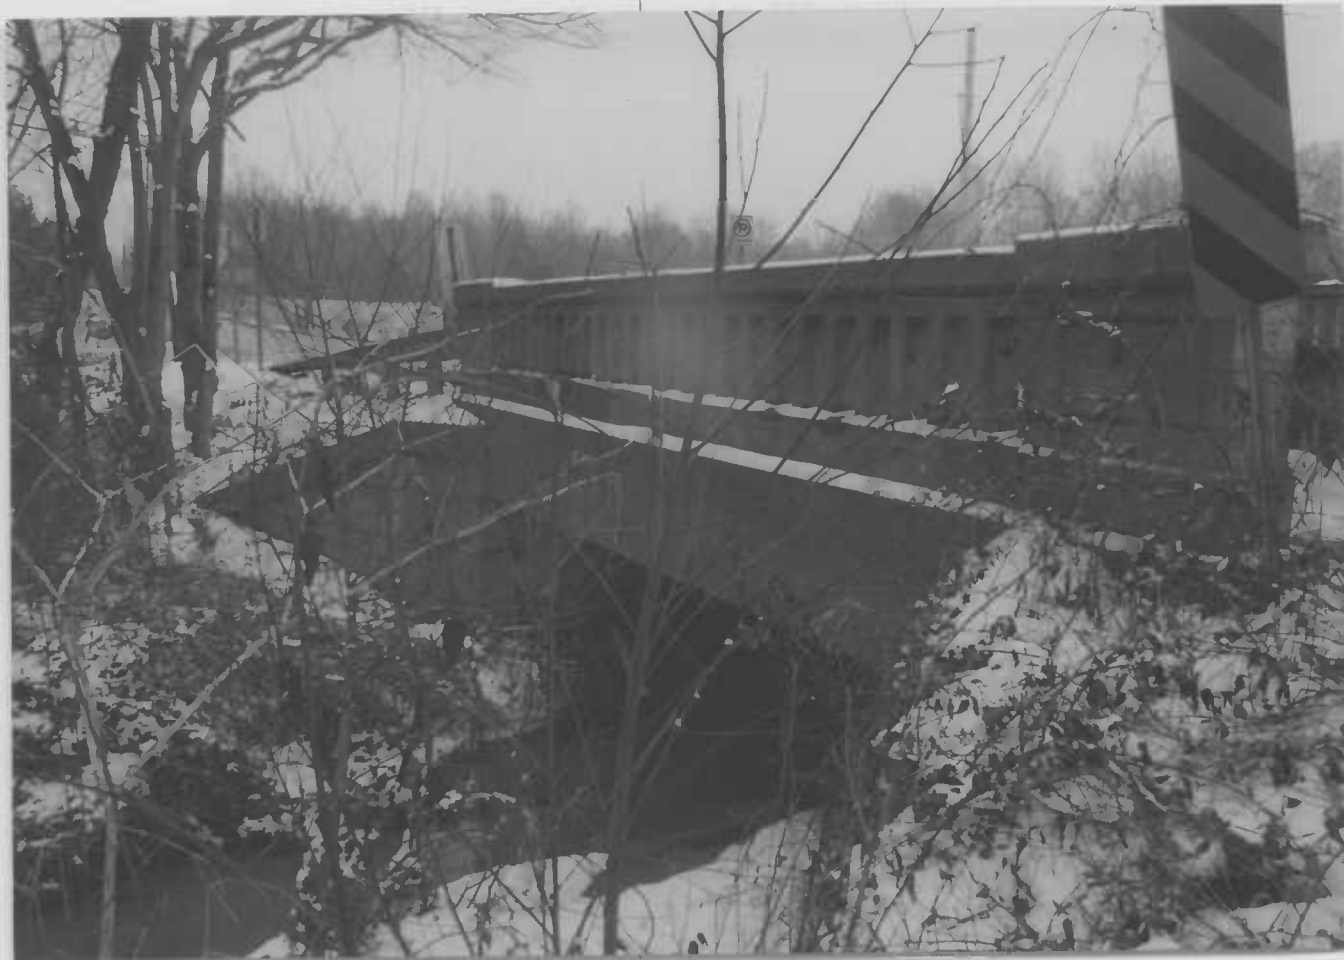
Number ² 24 of ⁴ 35

Description ELEVATION ~~NE~~ EAST

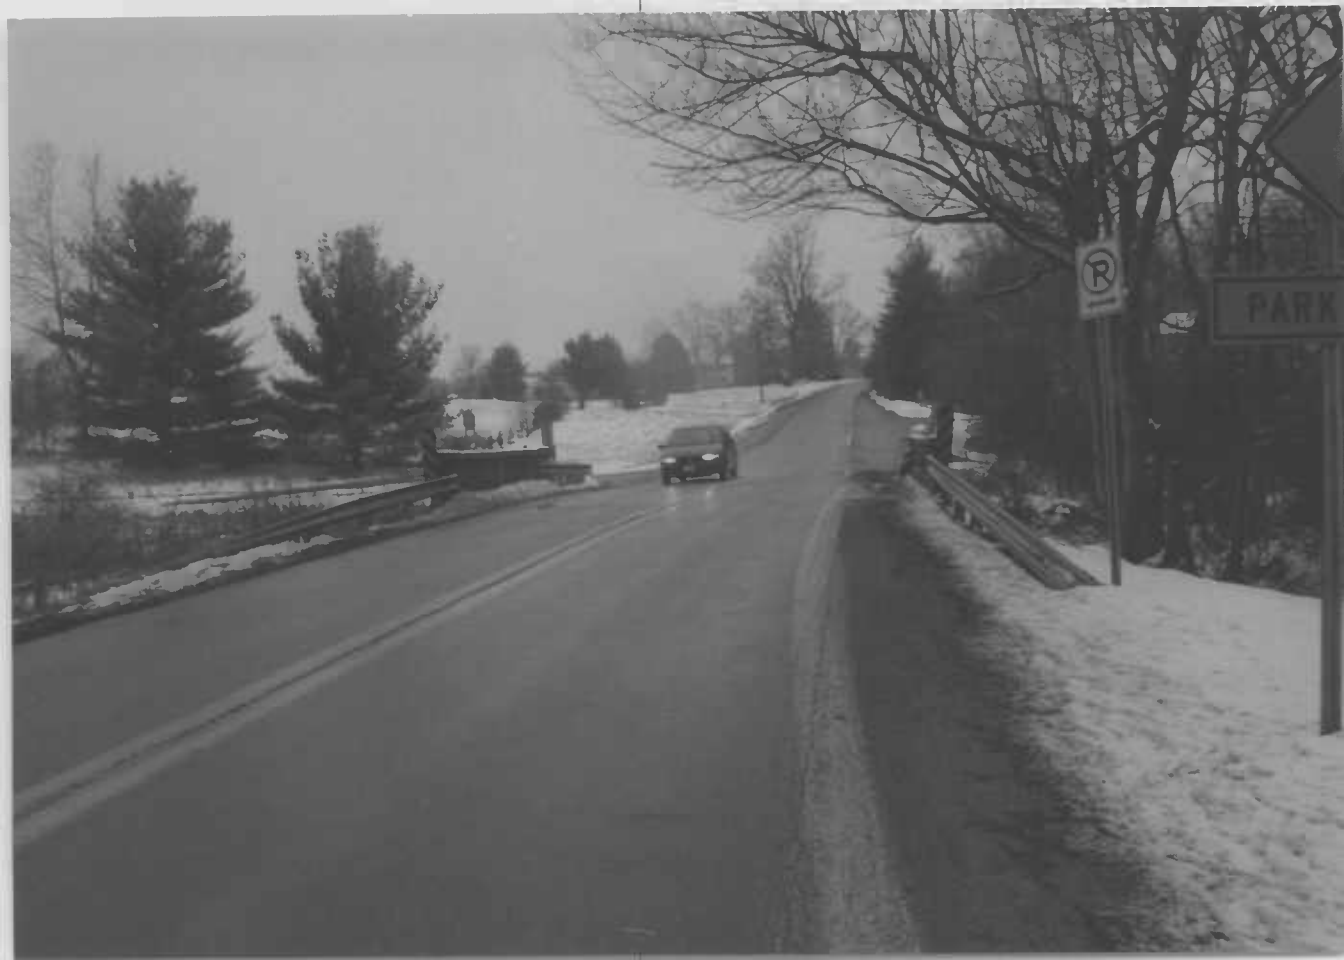
3 4
Number 28 of 38

Description APPROACH SOUTH

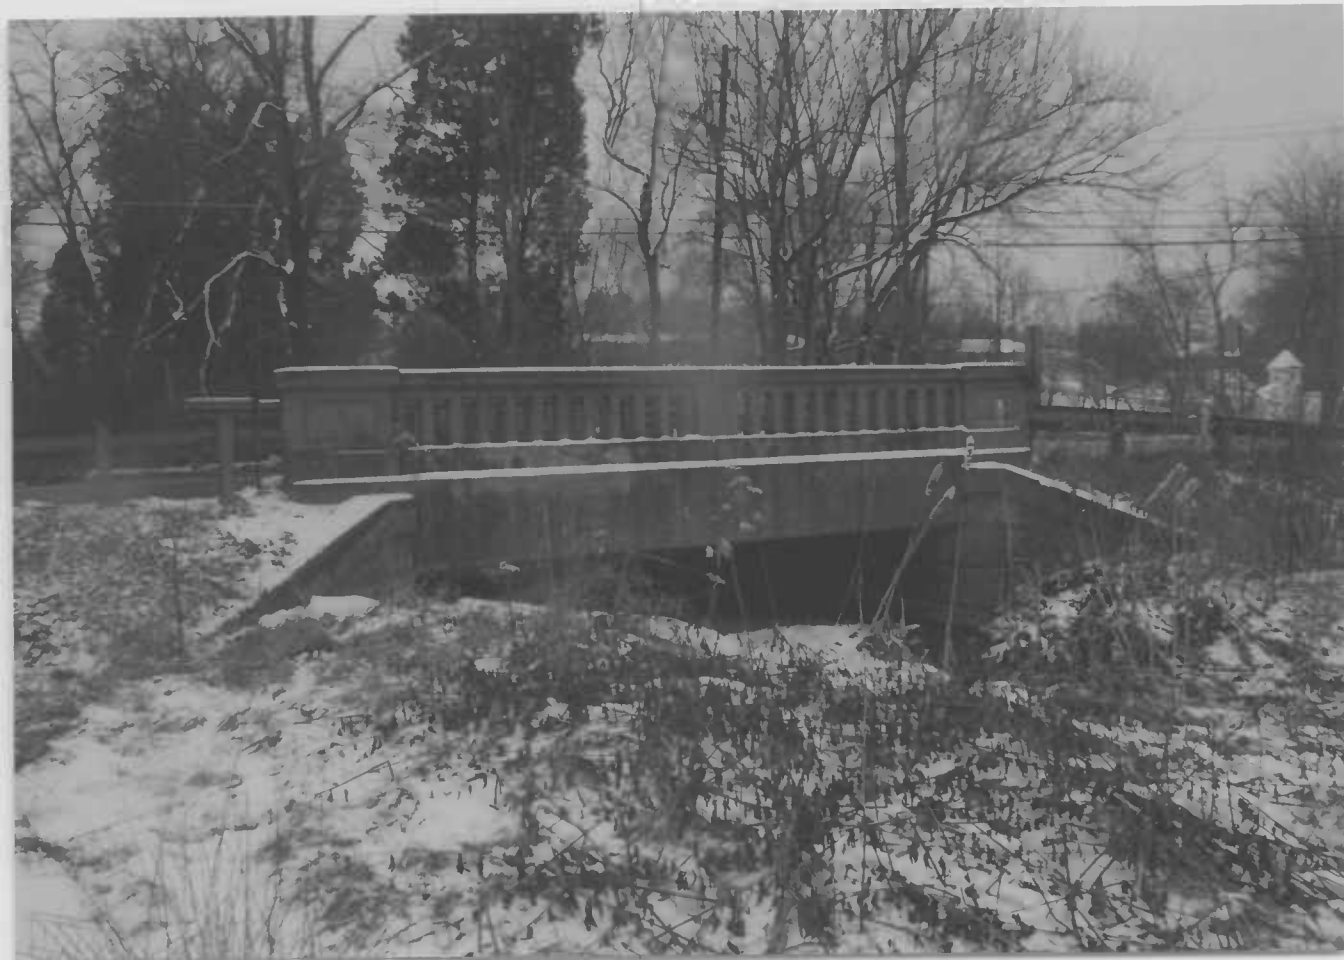
Number ⁴ 26 of ⁴ 35

Description ELEVATION WEST
